Report No: Monash/RT/2016/1144

VLOCITY WHEEL WEAR INVESTIGATION FOR V/LINE PTY LTD

P. Mutton, D. Welsby, S. Younes, M. Kwong

1 April 2016

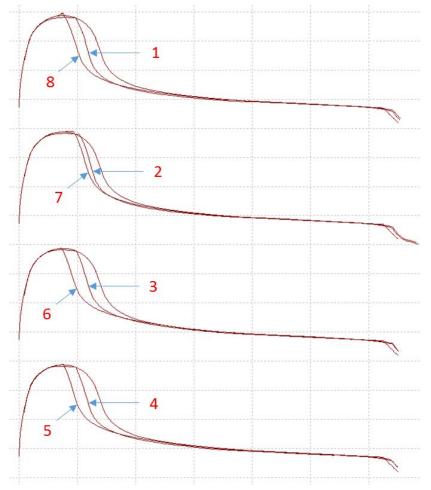
FIGURE 27: TYPICAL WEAR BIAS ON VLOCITY CAR

The left/right wear asymmetry noted previously is clearly evident in Figure 27, which shows an overlay of worn VLocity wheels for each axle against the MP2 template. In this example, wheels 1- 4 represent left side of the vehicle, while wheels 5-8 are on the right.

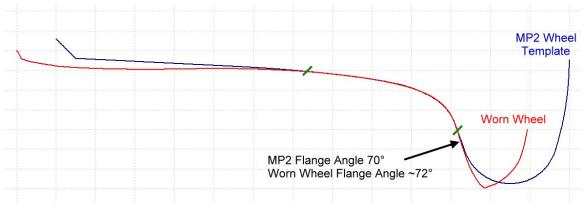
FIGURE 28: WHEEL THROAT ALIGNMENT - WORN VS. MP2 TEMPLATE

Also of interest is the worn wheel overlay with the MP2 wheel profile, when aligned within the throat region of the profile to see what changes have occurred as a result of wear. Figure 28 shows that the worn shape of the worn wheel matches well with that of the MP2 wheel in the throat area. Consequently, it could be said that high wear is not expected from a new/machined wheel due to any profile bedding in process. Note this does not include any adverse effects due to the roughened/machined surface (as discussed further in Section 6). The main change to profile, however, is the flange face angle which generally increases as the wheel wears. A new/machined MP2 profile contains a 70° flange face angle, which is typical of most Australian railway systems. Measurements of flange angle from worn wheels were on average around 72°, but as high as 75° (Figure 28).

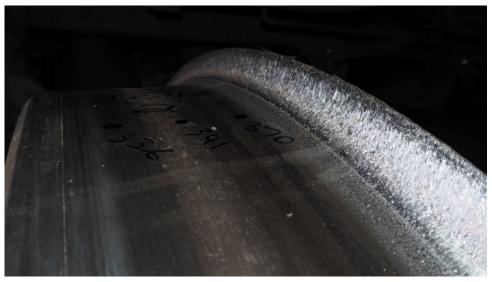
FIGURE 29: TYPICAL WORN VLOCITY WHEEL PRIOR TO MACHINING

The appearance of the worn flange surfaces on VLocity wheels prior to machining was consistent with severe sliding contact and heavy adhesive wear, resulting in heavily gouged and roughened surfaces (Figure 29). None of the inspected wheels were found to contain any significant (visible) rolling contact fatigue (RCF) or other tread defects.

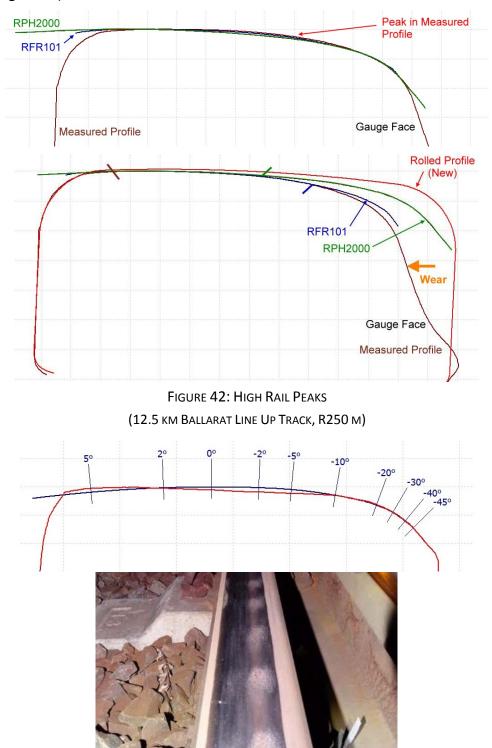
FIGURE 43: WORN LOW RAILS (1.362 KM NMFO, UP TRACK, R180 M)

has resulted in a typical 'flat' rail crown, extending out towards the field side edge. In the more severe cases, short pitch corrugations were observed through the main contact band (Figure 43).

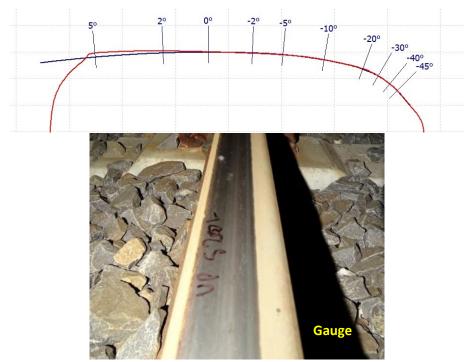
FIGURE 44: EXAMPLE OF FIELD BIAS ON LOW RAIL (5.200 km Up Track, R522 m)

In other less severe examples, the main contact band was close to the field side edge, rather than the desired central position. Measurements from these locations (Figure 44) showed substantial peaks in the field side of the profile. These peaks appeared to be the result of plastic flow, however residual profile anomalies (i.e. insufficient field relief during installation) cannot be ruled out without examining grinding/milling quality documentation.

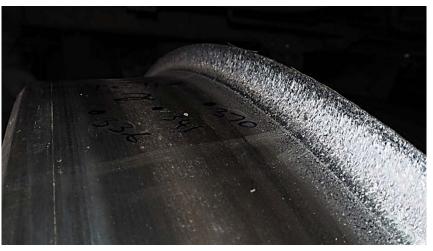
FIGURE 59: WORN VLOCITY WHEEL PRIOR TO MACHINING

The primary wear mode of concern in the current situation is Type 3 wear resulting from unlubricated contact between the wheel flange and the rail gauge face. On the wheel flange, this results in heavily-scored surfaces such as those illustrated in Figure 59 and 60.
