Report No: Monash/RT/2016/1144

VLOCITY WHEEL WEAR INVESTIGATION FOR V/LINE PTY LTD

P. Mutton, D. Welsby, S. Younes, M. Kwong

1 April 2016

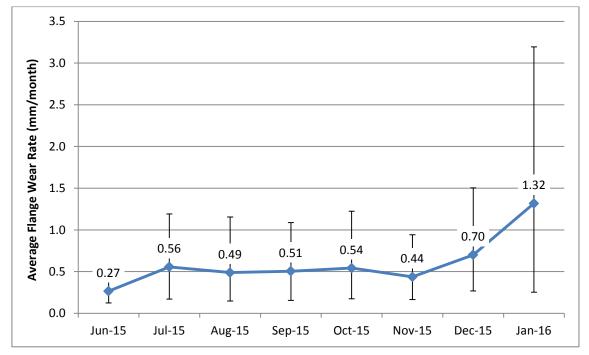
FIGURE 19: VLOCITY FLEET AVERAGE FLANGE WEAR RATE BY MONTH

Average flange wear rates (mm/month) for each month between the period June 2015 and January 2016 for the entire VLocity fleet are shown in Figure 19. The results showed flange wear rates averaged 0.27 mm/month in June 2015, then increased to ~0.5 mm/month in July 2015. This wear rate remained fairly stable until December 2015 when it rapidly increased to 0.7 mm/month and up to 1.3 mm/month in January 2016. There was also a considerable increase in the spread of flange wear rates in January 2016, as indicated by the error bars in Figure 19. This overall trend is consistent with the information provided by V/Line on the wheel flange wear rates of the VLocity fleet¹.

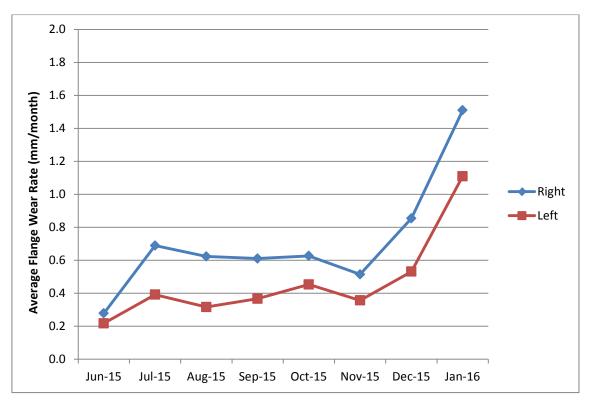
FIGURE 21: VLOCITY FLEET FLANGE WEAR RATE BY SIDE

Figure 21 shows the average flange wear rate of wheels separated by the left versus right side of the car. The right side of the VLocity (i.e. Side A of 11XX/13XX series car and Side B of 12XX series car) clearly showed a higher wear rate after July 2015 compared to the left side (i.e. Side A of 12XX series car and Side B of 11XX/13XX series car). However, the margin or difference did not appear to change significantly in the later months.

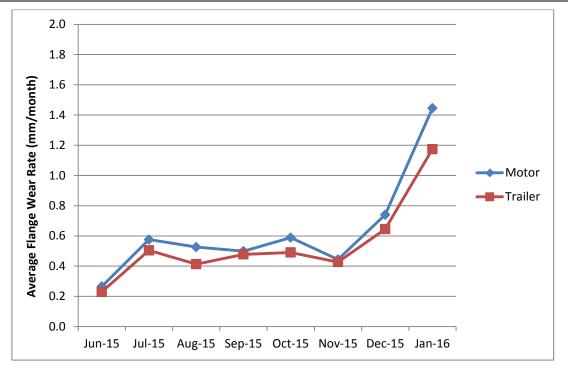
FIGURE 22: VLOCITY FLEET FLANGE WEAR RATE BY BOGIE TYPE

Figure 22 shows the average flange wear rate of wheels separated by bogie type for all cars (i.e. motor vs. non-driven trailer bogie). The results show that flange wear on the motor bogie is consistently higher than the non-driven trailer bogie, although the margin between them is less than that between the left and right sides (Figure 21). This characteristic is generally typical of railway vehicles since wheels on the driven motor bogie are subjected to greater tractive forces than non-driven wheels.

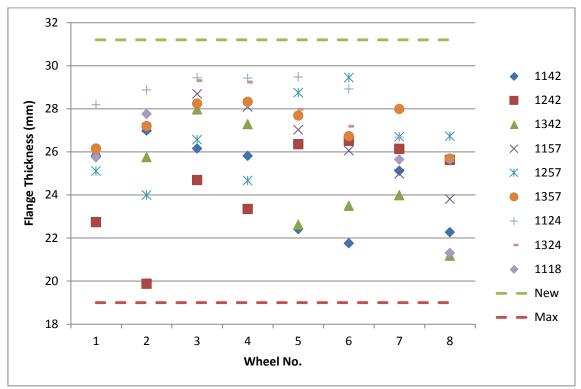
FIGURE 24: FLANGE THICKNESS FOR MEASURED VLOCITY CARS BY WHEEL POSITION

Figure 24 shows flange thickness (Sd) values of all measured VLocity car wheels prior to machining. These results show flange thickness to vary between 19 and 30 mm, however it should be noted that VLocity sets 18 and 42 were measured immediately before machining, hence at the lower end of the wear spectrum. Conversely, VLocity sets 24 and 57 were still in service at the time of measurement and consequently show a higher overall flange thickness.

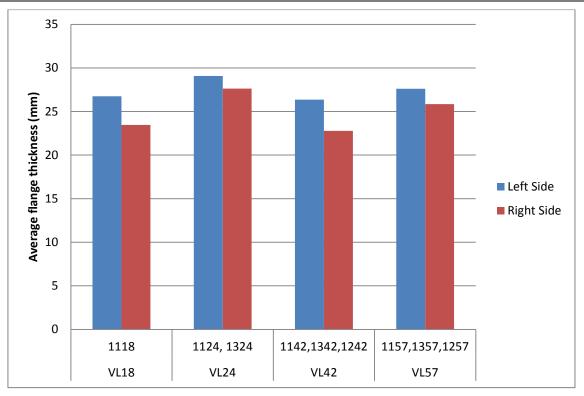
FIGURE 25: AVERAGE FLANGE THICKNESS FOR MEASURED VLOCITY CARS BY SIDE

The results in Figure 25 show a general right side flange wear bias for all cars (i.e. Side A for 1100/1300 cars and Side B for 1200 cars), which is consistent with a bias towards left hand curves in the RRL [2].

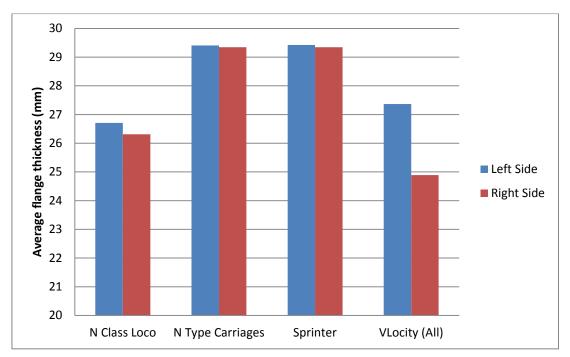
FIGURE 26: AVERAGE FLANGE THICKNESS FOR ALL WHEEL PROFILE MEASUREMENTS

The above analysis was extended to include the additional measurements taken on two N Class locomotives, three N type coaches and one Sprinter car. It can be seen from Figure 26 that the level of asymmetric flange wear on the VLocity cars is generally not as prominent on the other rolling stock types. In-fact, N coaches and Sprinter vehicles show no significant wear bias.

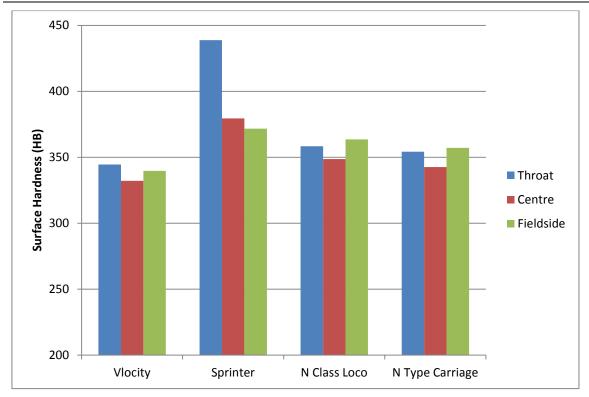
FIGURE 30: SURFACE HARDNESS FOR ALL WHEEL MEASUREMENTS

Average hardness levels ranged from 332 HB in the centre of the tread of the VLocity to 438 HB in the throat region for Sprinter. The hardness results for the VLocity are consistent with that expected for the specified (R8T) wheel material grade (255 – 285 HB), with some additional work hardening at the worn tread surface. The high hardness result on the throat of the Sprinter wheels indicates that this region of the wheel is under considerable strain and has significantly work-hardened as a result. This also indicates that wear in this area may not be particularly high.

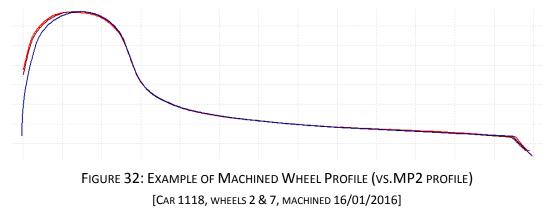
FIGURE 33: VARIATION BETWEEN MEASURED/MACHINED WHEEL PROFILE AND THE MP2 TEMPLATE. [Car 1118, wheels 2 & 7, machined 16/01/2016]

Figure 32 overlays a typical, post machining, measured transverse wheel profile with the MP2 template from which the variance between the two profiles is calculated. The resulting difference, known as the vertical residual, is plotted in Figure 33. From this, it can be seen the profile is generally within +/- 0.25 mm across the throat and tread region of the wheel, which is considered to be an acceptable accuracy.

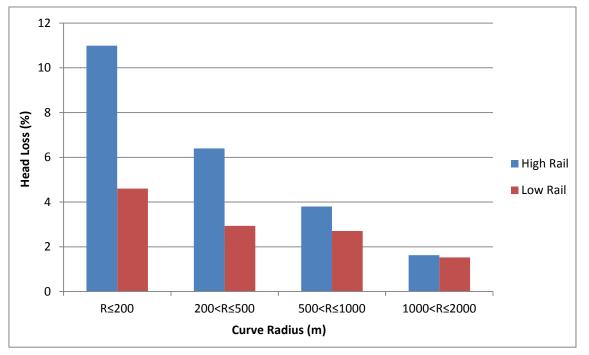
FIGURE 38: AVERAGE PERCENTAGE HEAD LOSS RESULTS (UP & DN TRACKS)

Average percentage head loss results for measured high and low rails are shown in Figure 38. These results show that high rails in moderate to very sharp curves have consistently higher wear than low rails. Furthermore, high rails show significantly increasing wear as curve radius reduces The sharpest curves (R<200m) yield the highest average percentage head loss at 11% and 4.7% for high and low rails respectively. Greatest high rail wear was found on the Up Track with 19% head loss on the 180 metre radius right hand curve on the NMFO. Conversely, the shallowest curves (R>1000m) yield the lowest average percentage percentage head loss at just 1.6% and 1.5% for high and low rails, respectively.

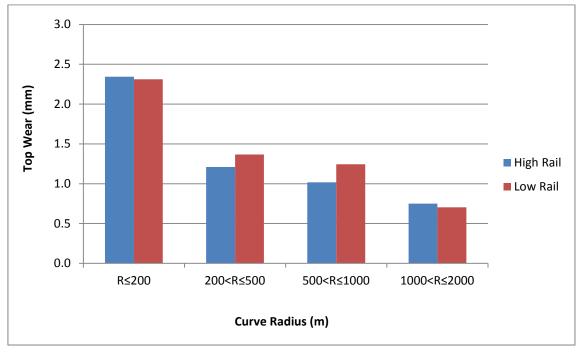
FIGURE 39: AVERAGE VERTICAL WEAR (W1) RESULTS (UP & DN TRACKS)

Similarly, average vertical rail wear results are shown in Figure 39. While the results show rails in sharper curves have consistently higher top wear in comparison to shallower curves, there is little difference between high and low rails. The sharpest curves (R<200 m) yield the highest average top wear of around 2.3 mm for both high and low rails, while the shallowest curves (R<1000 m) showed the lowest average top wear at around 0.7 mm for both high and low rails.

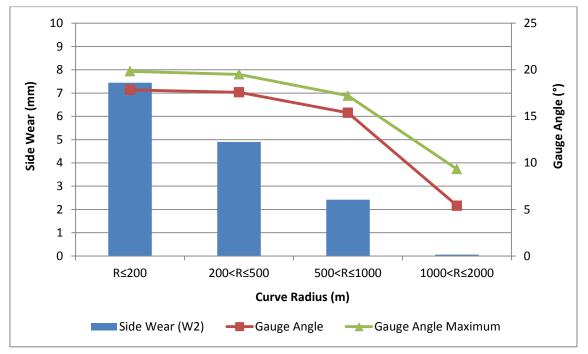
Average side wear results are shown in Figure 40, along with gauge angle. These results show that side wear generally only occurs in the moderate to very sharp curve ranges, increasing with reduced curve radius. The sharpest curves (R<200 m) showed the highest average side wear of around 7.4 mm, whilst the shallowest curves yield negligible side wear. The largest absolute wear was found on the Up Track on the North Melbourne Flyover with 13.8 mm side wear.

Gauge face angle results show increasing angles (gauge point or maximum) with increasing side wear and reducing curve radii. The greatest change appears to occur as side wear begins within the moderate curve range ($500 < R \le 1000$ m), then settling down once radius drops below 500 m. The largest gauge angle of 21.3° was found at the 1577.2 m measurement location on the Up Track (NMFO).

FIGURE 40: SIDE WEAR (W2) AND GAUGE FACE ANGLE RESULTS (UP & DN TRACKS)

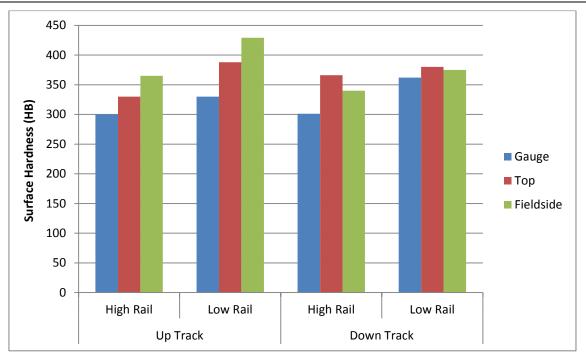
Average surface hardness results are shown in Figure 45 for measurements taken from the contact band of rails on both Up and Down tracks on the NMFO. It should first be noted that the base hardness of the rail is approximately 280 HB.

Results show only mild work hardening on the gauge corner of high rails, primarily due to the severity of wear occurring in this region of the rail. Hardness generally increases once out of the severe wear zone.

Work hardening on low rails appears to be more significant, particularly within the main contact areas (centre/top and field) of the contact band, where increases of over 100 points (HB) were measured. The greater work hardening on the Up Track low rail is indicative of higher contact stresses and cyclic strain on this rail.

FIGURE 45: SURFACE HARDNESS OF MEASURED RAILS (1398.7 M, UP/DN TRACK, NMFO)

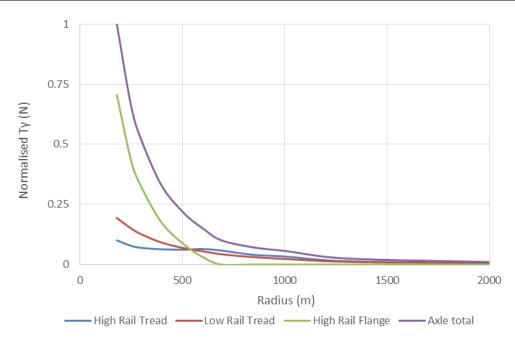
Simulated wear energy results ($T\gamma$) for curves below 500 m radius are shown in Figure 48, These results show that flange contact on the high rail (so-called high rail flange) is significantly higher than at the tread of either wheel (high or low rail tread contact). However, so as not to completely neglect changes that may occur to reported values on the tread, total axle (wheelset) $T\gamma$ is calculated and used to compare simulation cases, which incorporates all three contact points.

FIGURE 48: COMPARITIVE CONTRIBUTION OF TREAD, FLANGE AND TOTAL AXLE WEAR ENERGY (T γ)

For the case in Figure 48, the pre-existing unlubricated condition (μ = 0.5), contributions to the total axle wear at the tightest radius of 180 m are 70.6%, 10.1% and 19.3% for High Rail Flange, High Rail Tread and Low Rail Tread respectively.

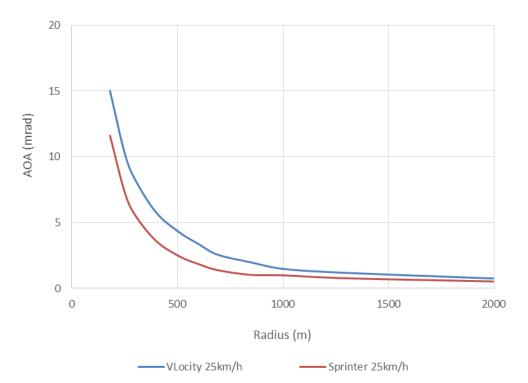
Figures 49 and 50 show the predicted AOA and wear energy $(T\gamma)$ results, respectively, for various curve radii. Both sets of results show AOA and wear for the Sprinter configuration is approximately 22% lower than the VLocity, highlighting a clear

relationship between primary longitudinal suspension stiffness, wheelset steering and associated wear.

FIGURE 49: PREDICTED AOA FOR VLOCITY AND SPRINTER VEHICLES

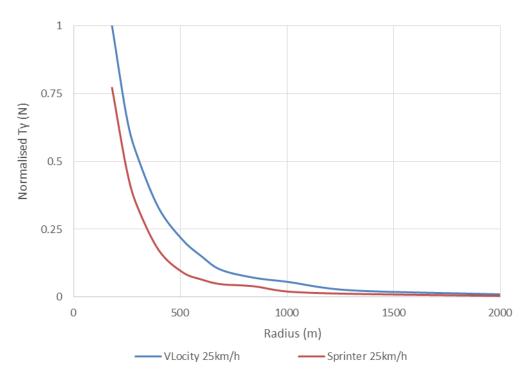
Figure 50: Relative Total Axle T γ for VLOCITY and Sprinter Vehicles

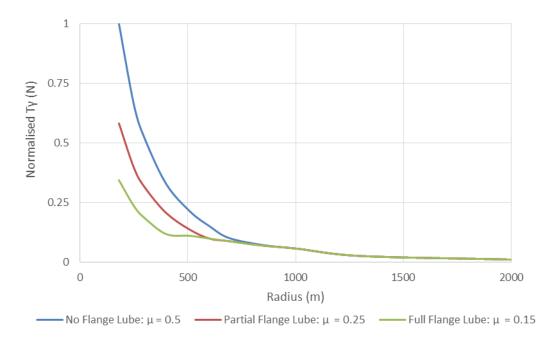
Simulation results in Figure 51 show a substantial reduction in wear (T γ) due to the use of lubricant for all curves below 600 m radius, and with increasing effectiveness as curve radius tightens. However, the most significant benefits can be found in curves of 400 m radius and below. At a radius of 180 m for example, simulated T γ is 58.2% and 34.4% of unlubricated values for partial and fully lubricated conditions, respectively. Hence, the benefits of flange/gauge face lubrication are clearly demonstrated.

Figure 51: Relative T γ for Vlocity Model with Varying Flange/Gauge Face Friction

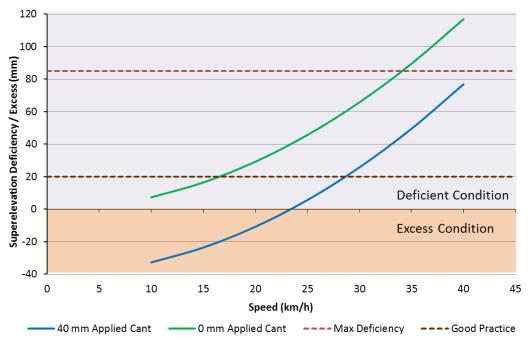
The effective superelevation deficiency/excess for the two above cases is plotted in Figure 52. From this, it can be seen that case two, with no applied rail cant and higher operating speed, will transition the curves at a more desirable "deficient" level than the current situation (Case 1) which would be in excess.

FIGURE 52: SUPERELEVATION DEFICIENCY/EXCESS VS. SPEED

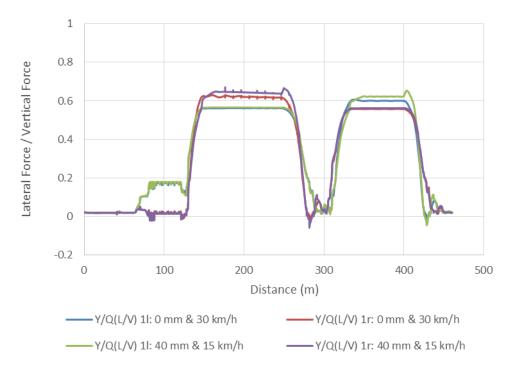
In addition, L/V results, reported in Figure 53 indicate that, for the wheels with highest risk of derailment (being 1R in the 1st curve and 1L in the 2nd in the down direction of travel) derailment risk is slightly decreased.

FIGURE 53: SIMULATED L/V RATIO COMPARISON OVER THE NORTH MELBOURNE FLYOVER

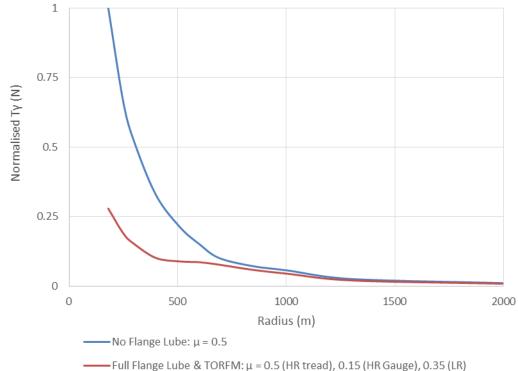
Results for both the Low Rail Ty (Figure 54) and Total Ty (Figure 55) show improvements in wear energy of 32% and 67% respectively.

While the latter represents only a 1% improvement in wear over the full flange lubrication case (Figure 51) at a radius of 180m, the CI results presented in Figure 56 show a significant decrease in the predicted corrugation growth of 37% at 180m radius. This reduction would be expected to significantly reduce the growth rate of corrugations observed on some low rails within sharp radius curves on the V/Line network.

FIGURE 55: RELATIVE TOTAL Tγ FOR VLOCITY MODEL WITH VARYING FRICTION ON THE WHEEL FLANGE DUE TO APPLICATION OF GREASE LUBRICANT TO THE HIGH RAIL GAUGE FACE AND TOR FRICTION MODIFIER APPLIED TO THE LOW RAIL

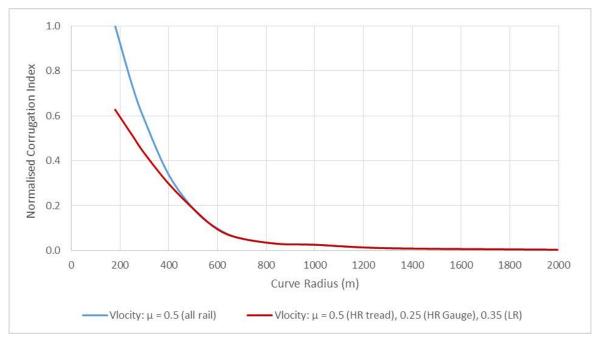
FIGURE 56: NORMALISED CORRUGATION INDEX COMPARISON FOR LOW RAIL

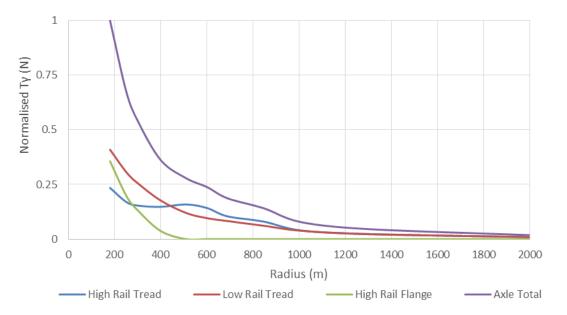
Figure 57 presents these proportions for the case where lubricant has been applied to both the gauge corner of the high rail (grease: $\mu = 0.15$) and to the top of the low rail (TOR Friction Modifier: $\mu = 0.35$). Figure 55 in Section 5.4.4 above showed that, in total, this case reports a Ty 67% lower than the unlubricated condition but significantly, from Figure 57, it is shown that the ratio of flange to tread dissipation has changed to now be 35 : 65 with more energy being dissipated in the tread.

This should not be taken to imply that tread wear would subsequently be greater than flange wear. Consideration must be given to the much greater surface area that the energy is consumed by in the tread in relation to the flange. Subsequently, flange wear may still be greater, but at a much lower level than is currently the case.

Figure 57: Comparative Contribution of High Rail Tread, High Rail Flange and Low Rail Tread to Total Tγ Where Lubricant Applied to Both High and Low Rail

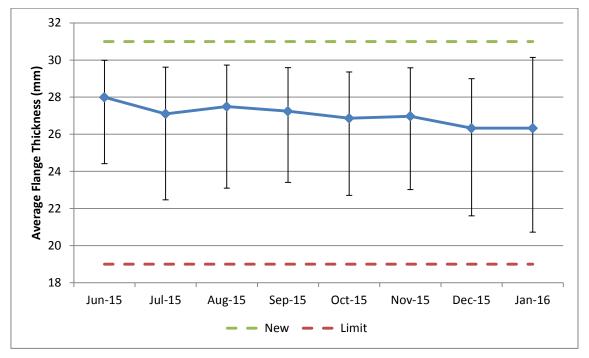
The wheel wear data also shows that the average flange thickness of the VLocity fleet decreased slightly between June and July 2015 (Figure 65). However this trend does not necessarily reflect the influence of the RRL operations, as not all Vlocity trains are inspected on a monthly basis. The VLocity flange thickness data does show, however, that monthly average flange thickness levels continued to decrease through till December 2015, with an increase in the range of flange thickness levels apparent in January 2016.

FIGURE 65: VLOCITY FLEET AVERAGE FLANGE THICKNESS BY MONTH

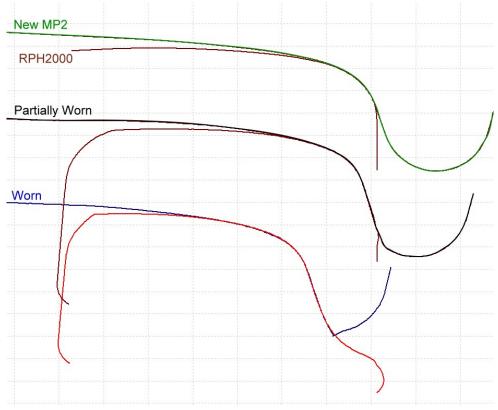
The change in rail profiles in the sharper curves to result in the rail condition evident during the inspection performed by IRT in mid-February, would have resulted in a marked deterioration in wheel/rail contact conditions as illustrated in Figure 66. The upper combination of new MP2 wheel profile and RPH2000 rail profile provides uni-point contact around the gauge corner, with negligible contact down the gauge face. Potentially higher contact stress levels at the gauge corner could be expected with this profile combination, but wear rates would be relatively low.

In a partly-worn condition (middle combination in Figure 66), there is more extensive contact between the wheel flange and the rail gauge face, which would have given rise to a marked increase in wear rates.

In the fully-worn condition, the contact extends to the tip of the flange and slightly lower down the rail gauge face, further increasing wear rates and also resulting in the development of arises on the wheel flange.

FIGURE 66 : WHEEL/RAIL PROFILE COMBINATIONS ILLUSTRATING THE TRANSITION FROM A LOW WEARING TO HIGH WEARING CONDITION

Throughout the period discussed above, no lubrication was in use in the sharper curves in the RRL. Hence both partially-worn and fully-worn conditions would result in the severe (Type 3) wear damage apparent on the wheel flanges and the lack of any significant work-hardening on the rails. Once lubrication of the sharper curves was implemented in early 2016, wear rates would be expected to decrease although the effectiveness of the lubricant would have been compromised by the high-wearing profile combination and the rough surfaces which were generated previously. Lubrication would be expected to become more effective (i.e. the lubricant would be expected to perform for a longer period) as the surface roughness levels decreased.

Based on the combination of wheel and rail profiles shown in Figure 66 above, wheel flange wear rates in the sharper curves would be expected to improve following the recent re-railing of the sharp curves in the NMFO, provided the newly-installed rails were ground or milled to the RPH2000 profile as previously recommended [3].

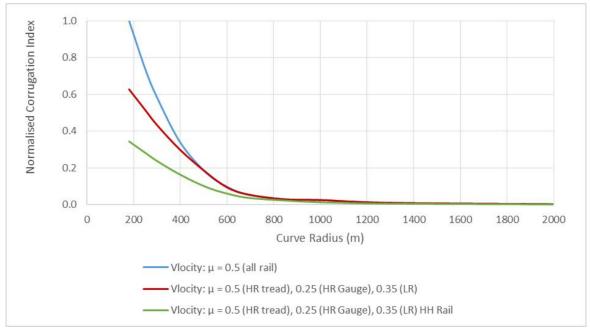
Also of interest are the combined benefits of improved rail material and the use of TORFM on corrugation development. Figure 68 shows the earlier results for the current rail material as well as the expected further benefit of utilizing head hardened rail. By using head hardened rail in conjunction with TORFM, corrugation development in the low rail is expected to be reduced by over 60% from the current level.

FIGURE 68: NORMALISED CORRUGATION INDEX - TORFM & HEAD HARDENED RAIL

manufacturer's recommendations. Alternatively, further investigation could be undertaken into the use of other TORFM products that do not drop the available friction level as far when over applied.

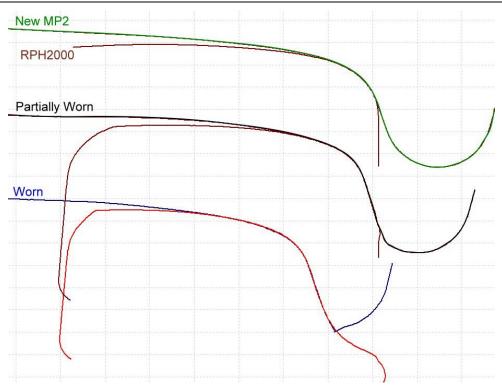
- d). Over the above period there would have been a marked deterioration in wheel/rail contact conditions as illustrated in Figure 69.
 - The upper part of this figure shows a combination of new MP2 wheel profile and RPH2000 rail profile which results in a uni-point contact around the gauge corner, with negligible contact down the gauge face. Potentially higher contact stress levels at the gauge corner could be expected with this profile combination, but wear rates would be relatively low.

- In a partly-worn condition (middle combination in Figure 69), there is more extensive contact between the wheel flange and the rail gauge face, which would have given rise to a marked increase in wear rates.

- In the fully-worn condition, the contact extend to the tip of the flange and slightly lower down the rail gauge face, further increasing wear rates and also resulting in the development of arises on the wheel flange.

FIGURE 69: WHEEL/RAIL PROFILE COMBINATIONS ILLUSTRATING THE TRANSITION FROM A LOW WEARING TO HIGH WEARING CONDITION

- e). Throughout the period discussed above, no lubrication was in use in the sharper curves in the RRL. Hence both partially-worn and fully-worn conditions would result in severe wear damage and a substantial increase in wear rates.
- f). Under these adverse contact conditions, the relatively low wear resistance of current wheel and rail material was unable to combat or control the high rate of wear.
- g). Once lubrication of the sharper curves was implemented in early 2016, wear rates would be expected to decrease, although the effectiveness of the lubricant would have been compromised by the high-wearing profile combination and the rough surfaces which were generated previously. Lubrication would be expected to become more effective (i.e. the lubricant would be expected to perform for a longer period) as the surface roughness levels decreased.

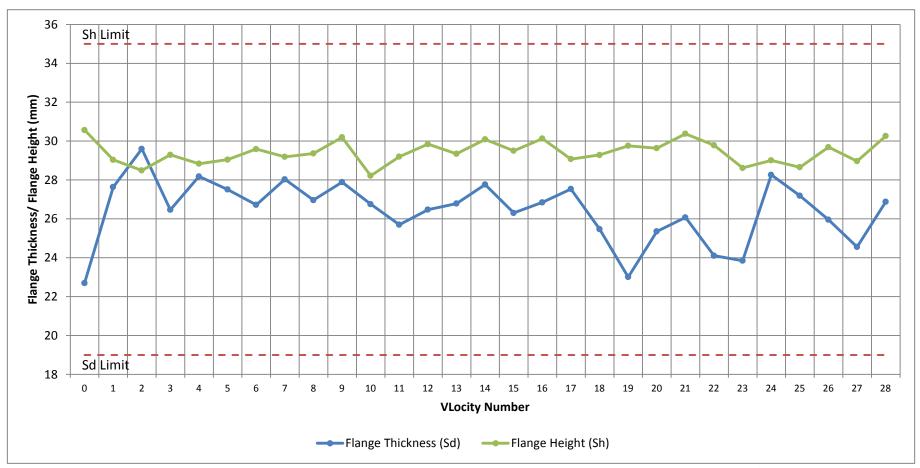
FIGURE C1: VLOCITYFLEET (VLO-VL28) AVERAGE FLANGE THICKNESS AND FLANGE HEIGHT (AS OF LAST INSPECTION, BEFORE 31ST JANUARY 2016)

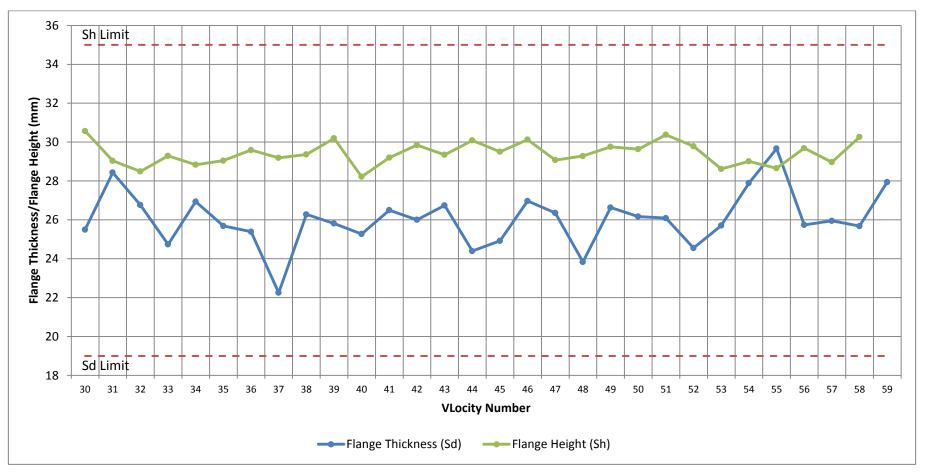
FIGURE C2: VLOCITY FLEET (VL30-VL59) AVERAGE FLANGE THICKNESS AND FLANGE HEIGHT (AS OF LAST INSPECTION, BEFORE 31ST JANUARY 2016)

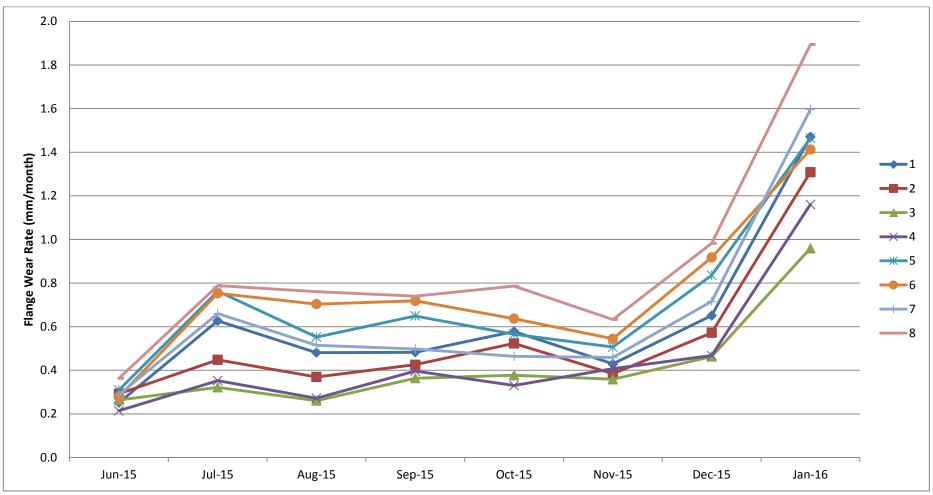
FIGURE C3: FLANGE WEAR RATE MEASUREMENTS FOR ALL WHEELS – 11XX SERIES CAR

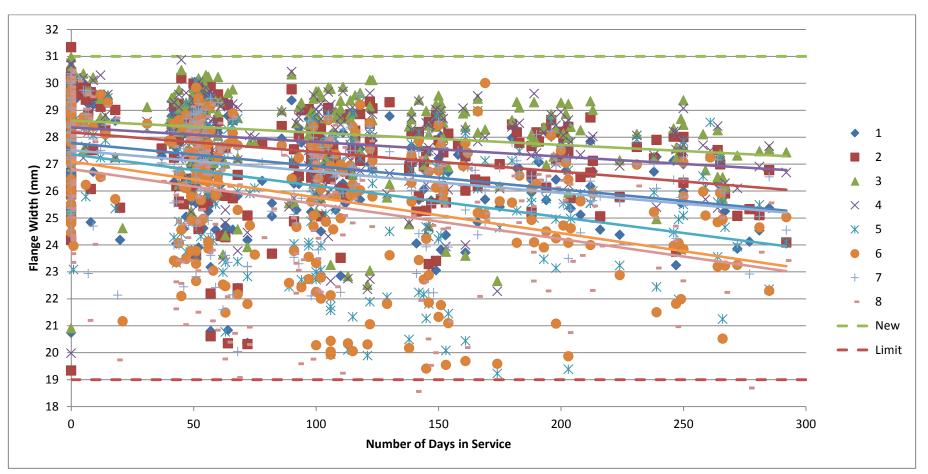
FIGURE C4: FLANGE WIDTH MEASUREMENTS (SD) FOR ALL WHEELS – 11XX SERIES CAR

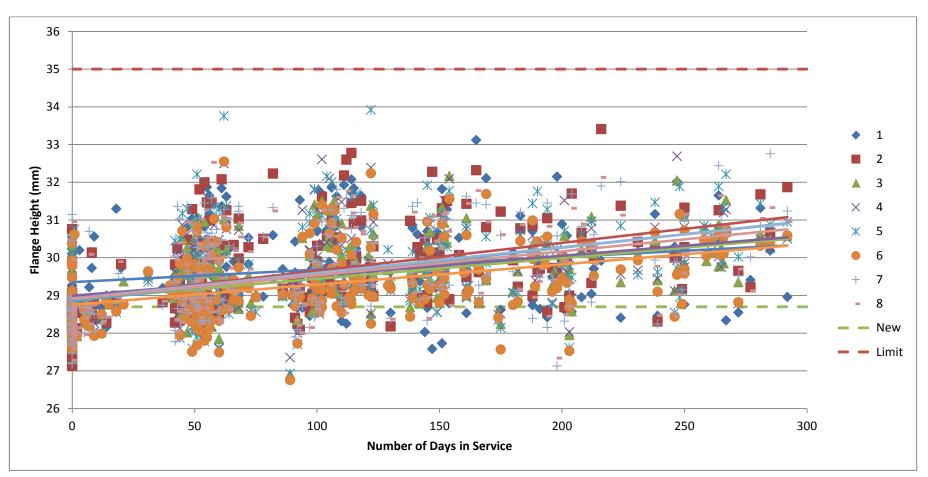
FIGURE C5: FLANGE HEIGHT MEASUREMENTS (SH) FOR ALL WHEELS – 11XX SERIES CAR

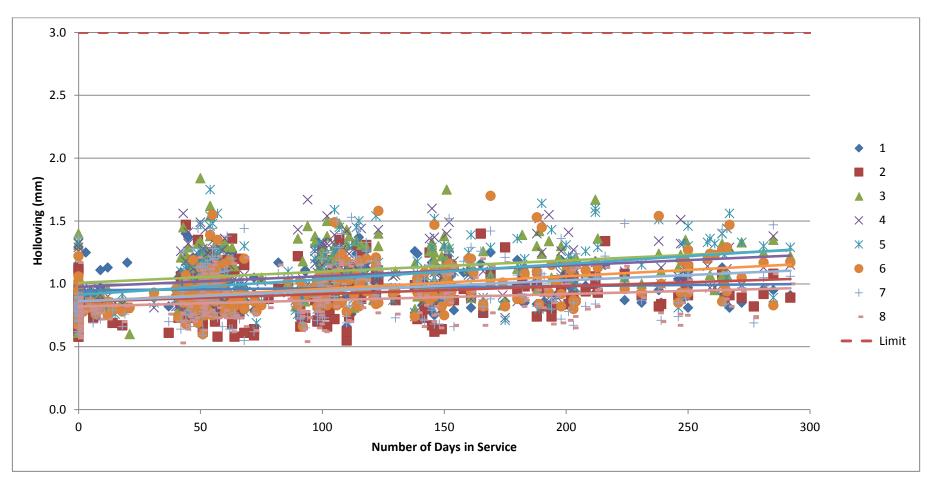
FIGURE C6: WHEEL HOLLOWING MEASUREMENTS FOR ALL WHEELS – 11XX SERIES CAR

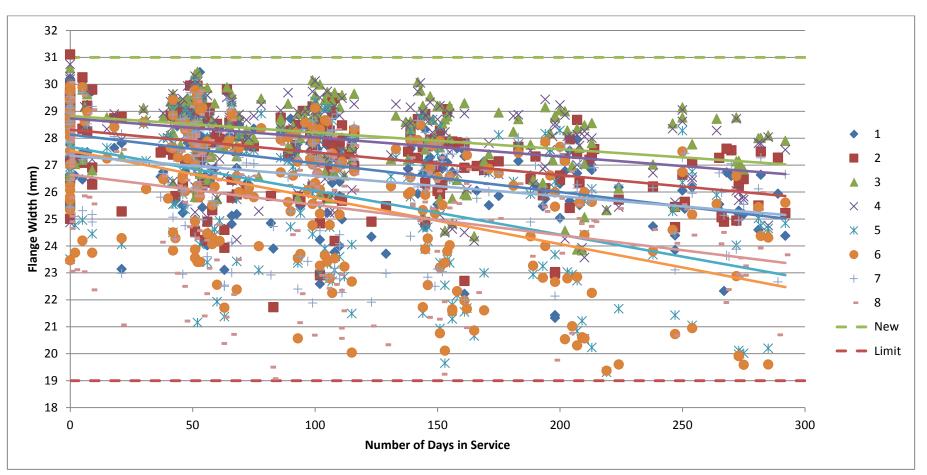
FIGURE C8: FLANGE WIDTH MEASUREMENTS (SD) FOR ALL WHEELS – 13XX SERIES CAR

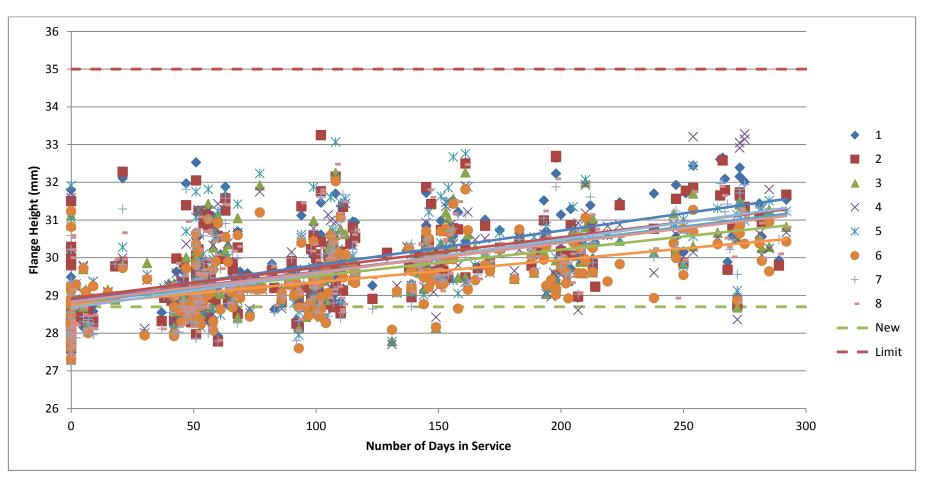
FIGURE C9: FLANGE HEIGHT MEASUREMENTS (SH) FOR ALL WHEELS – 13XX SERIES CAR

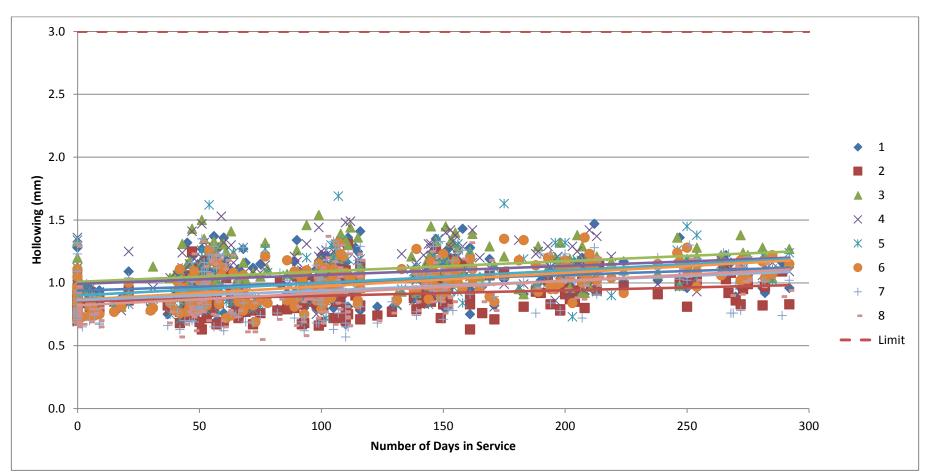
FIGURE C10: WHEEL HOLLOWING MEASUREMENTS FOR ALL WHEELS – 13XX SERIES CAR

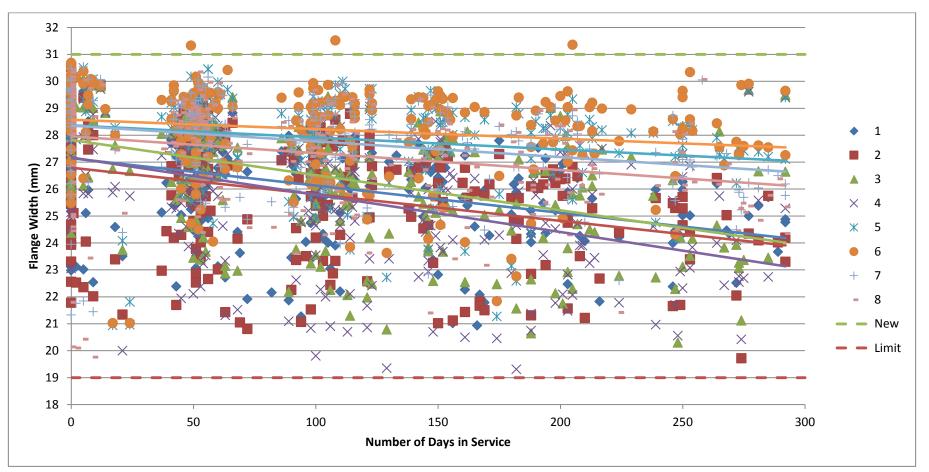
FIGURE C12: FLANGE WIDTH MEASUREMENTS (SD) FOR ALL WHEELS – 12XX SERIES CAR

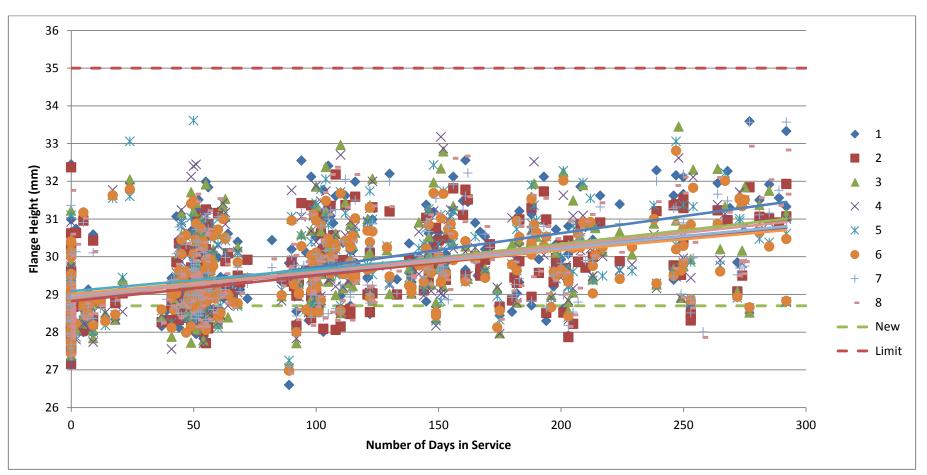
FIGURE C13: FLANGE HEIGHT MEASUREMENTS (SH) FOR ALL WHEELS – 12XX SERIES CAR
